NATIONAL TRANSPORTATION SAFETY BOARD

RAILROAD ACCIDENT REPORT

ILLINOIS CENTRAL GULF
RAILROAD COMPANY
FREIGHT TRAIN DERAILMENT
HAZARDOUS MATERIAL RELEASE
AND EVACUATION
MULDRAUGH, KENTUCKY
JULY 26, 1980

NTSB-RAR-81-1

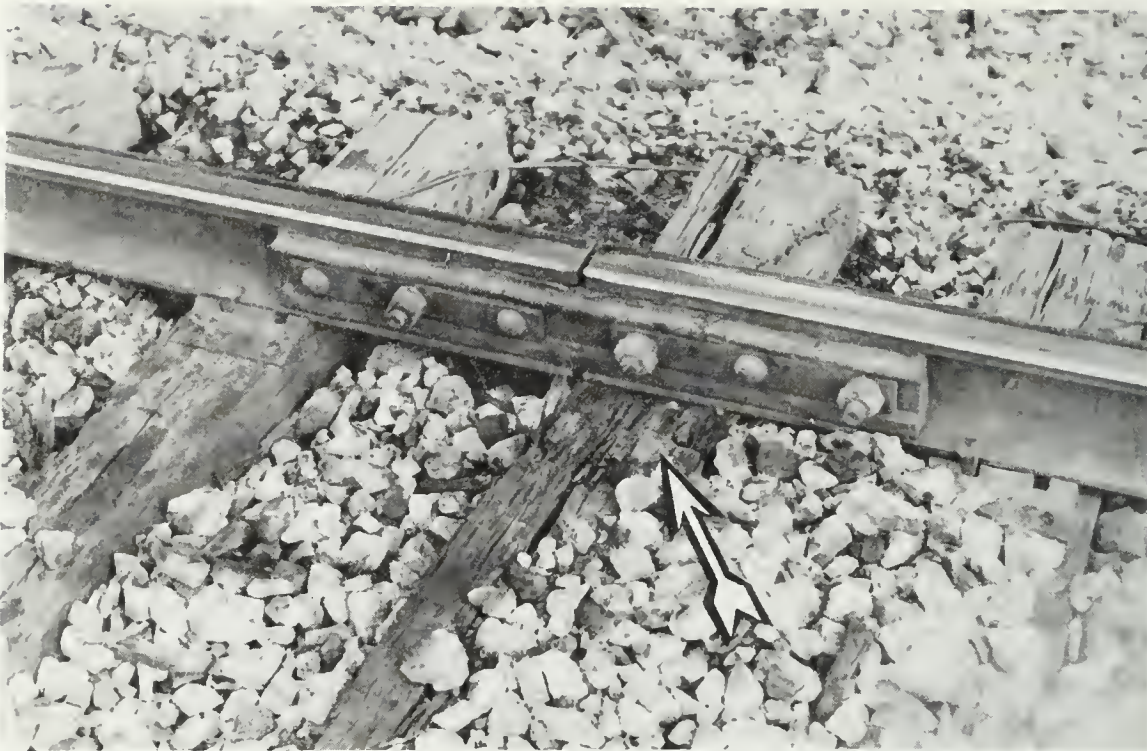
Figure 2.—Defective crosstie marked by yellow dot (arrow)
216 feet before the point of derailment.

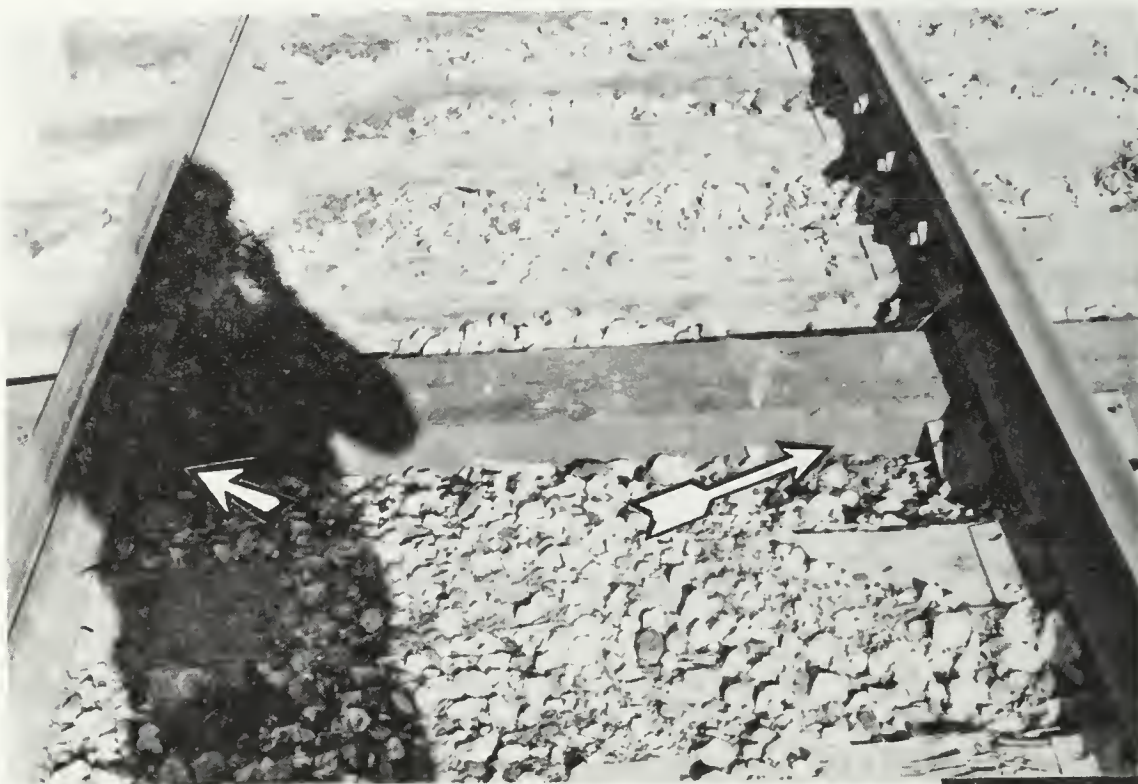
Figure 3.—Unspiked new crosstie about 300 feet
south of the point of derailment.

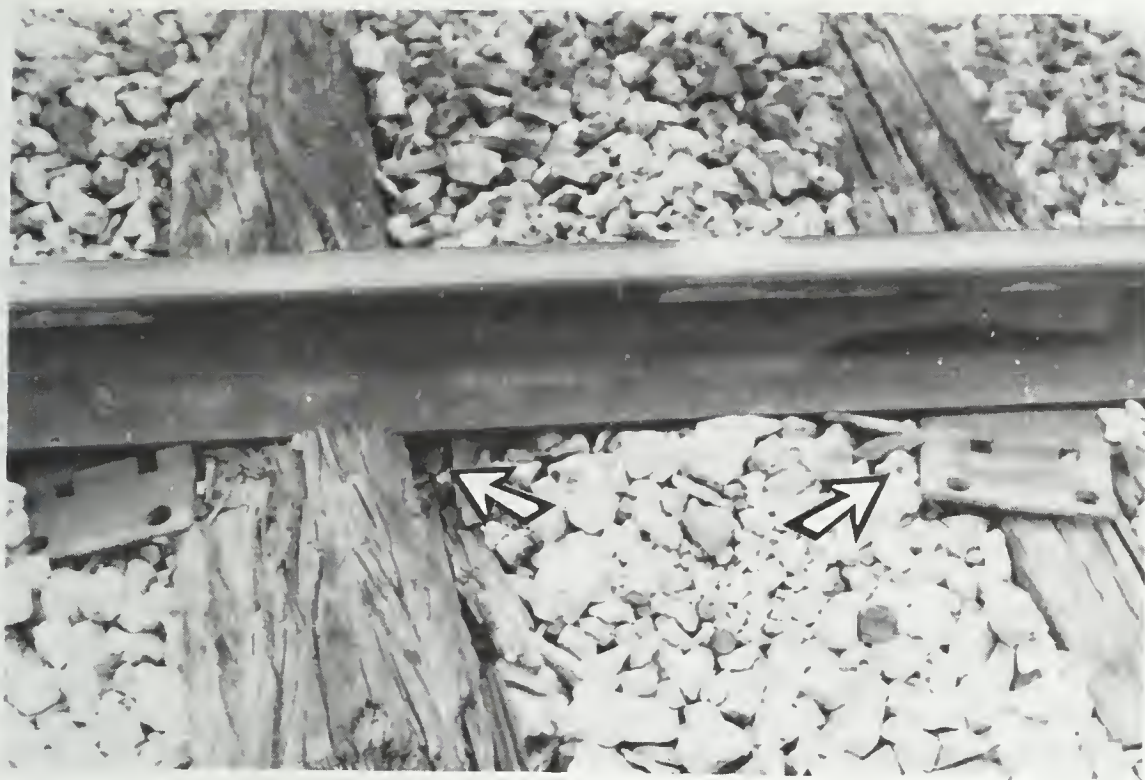
Figure 4.—Improperly installed and unspiked tieplates in derailment area.

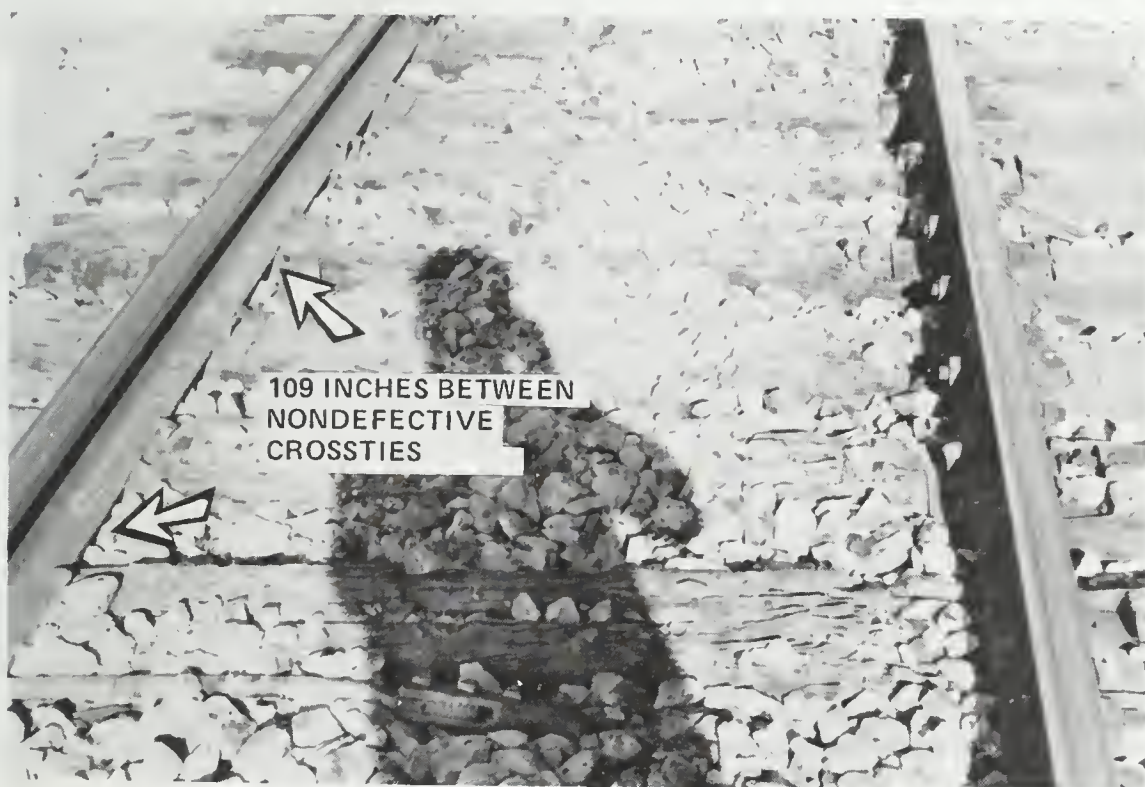
Figure 5.—Four adjacent defective crossties at the accident site.

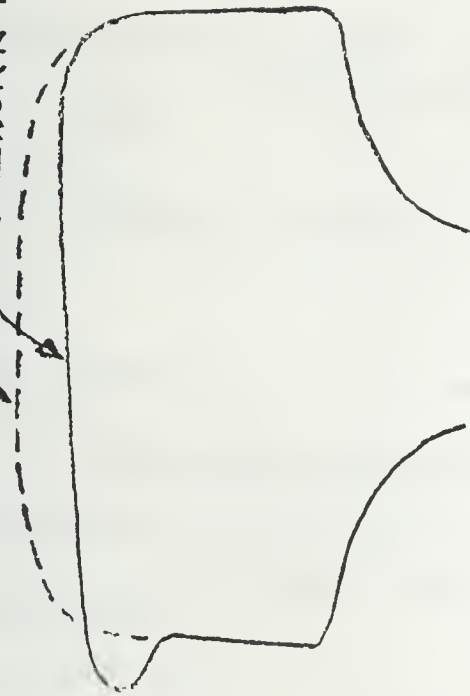
EAST RAIL, STA 31+27

A postaccident inspection revealed that the gage side of the head of the outside rail of the 6° curve was reduced between 28 to 44 percent of its surface. (See appendix E.) The ICG inspector who made the July 24, 1980, inspection said he noticed flange marks on the top of joint bars at milepost 27.5. He said he attributed the flange marks to railhead wear and curve-worn rail on the high side of the curve which would permit the flanges of the wheels to contact the joint bars. He did not note these conditions on the inspection report.

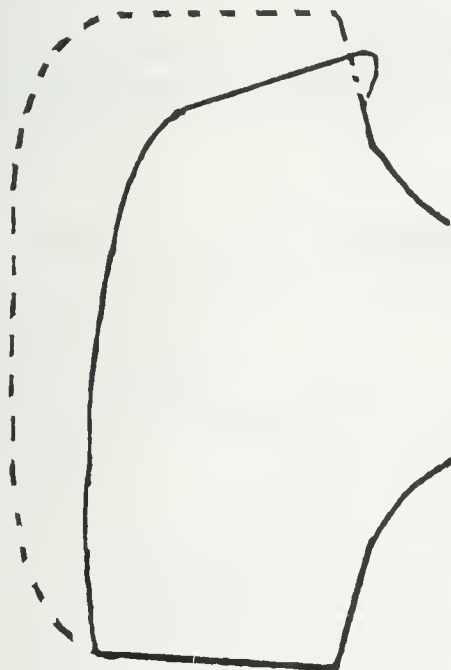
WEST RAIL, STA 30+71
28% WEAR

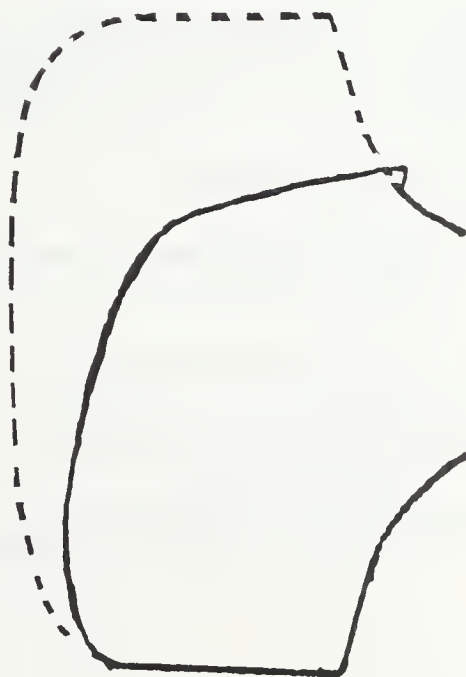
WEST RAIL, STA 34+27
44% WEAR

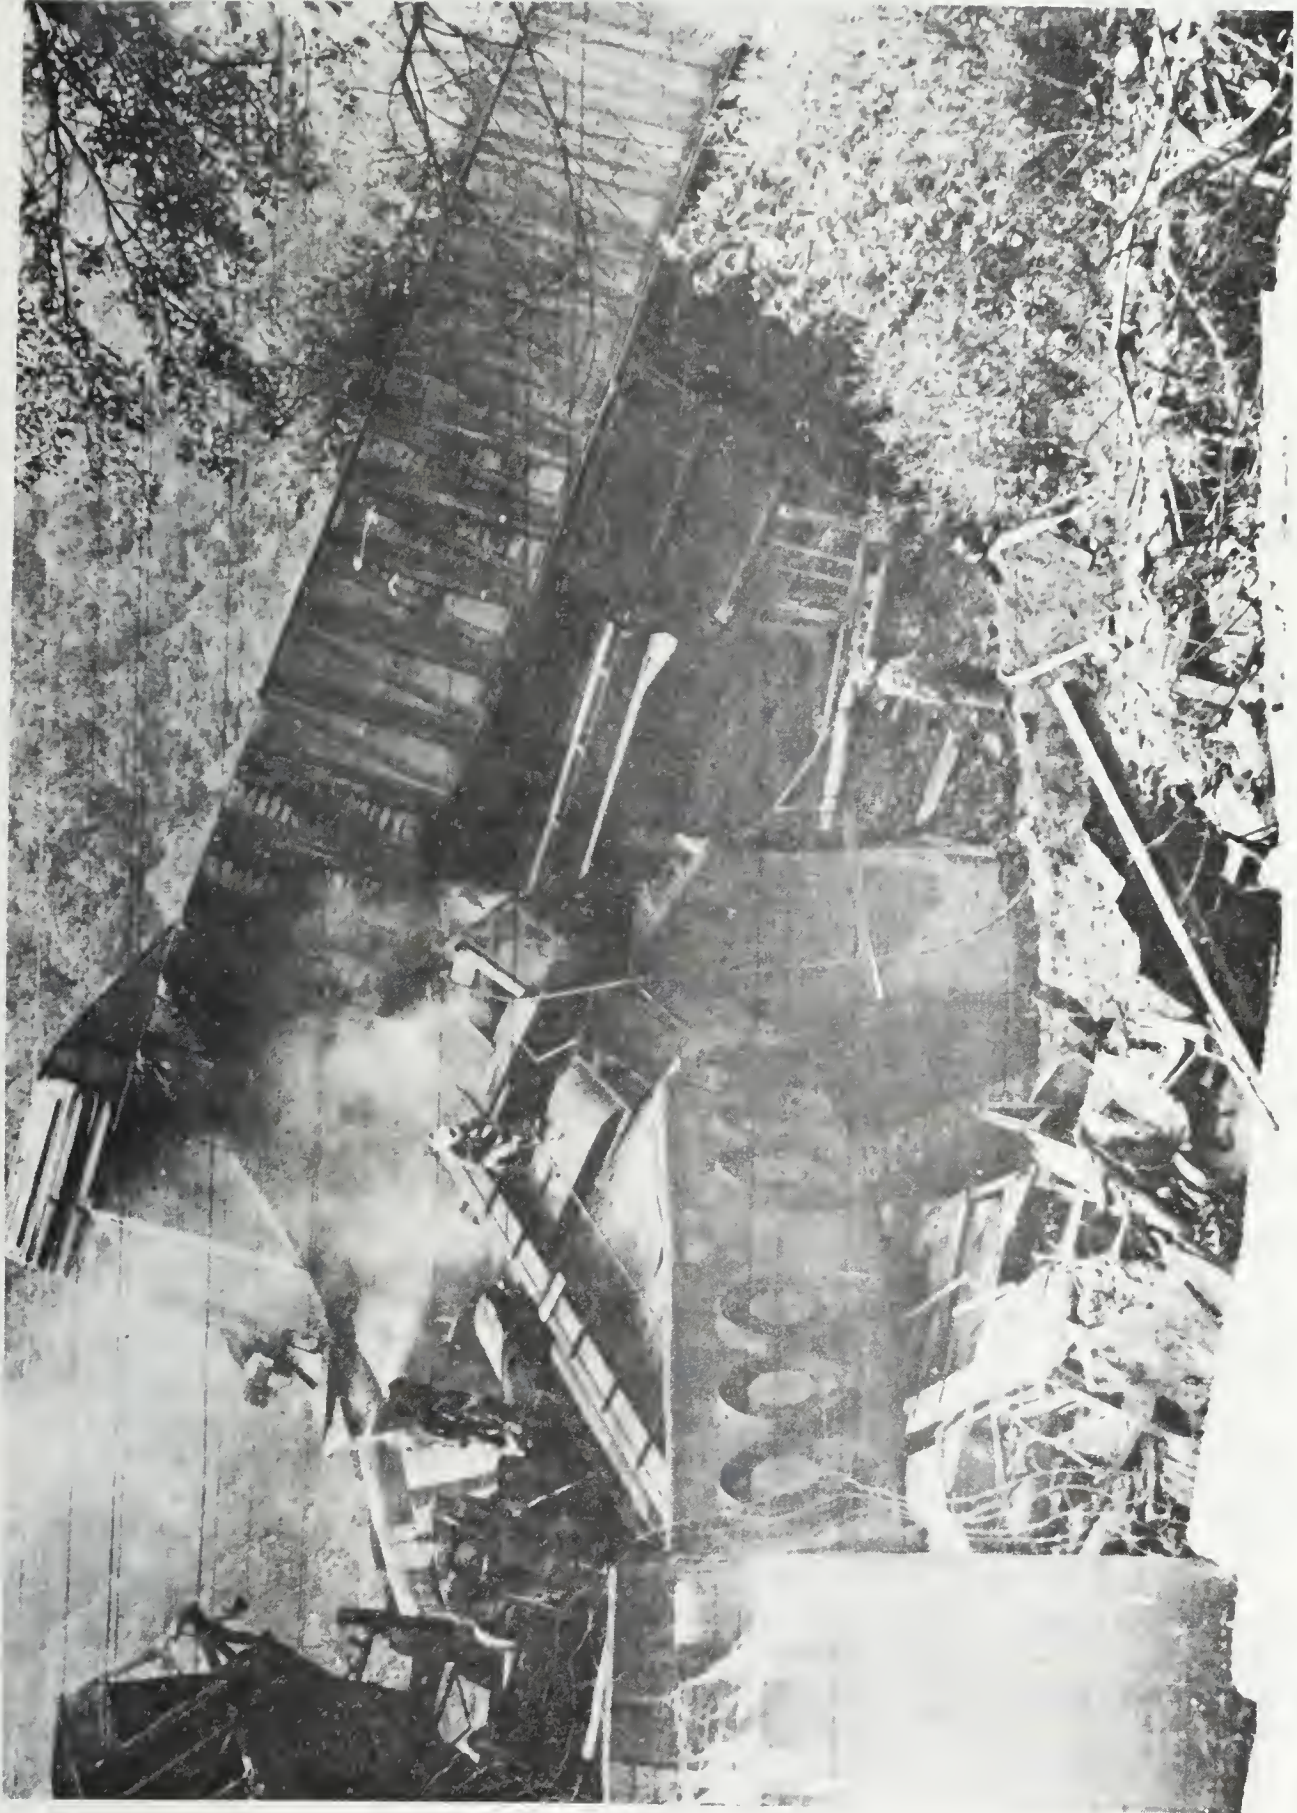
Figure 2.--Wreckage of train No. 86 after it
struck Extra 1589 West.

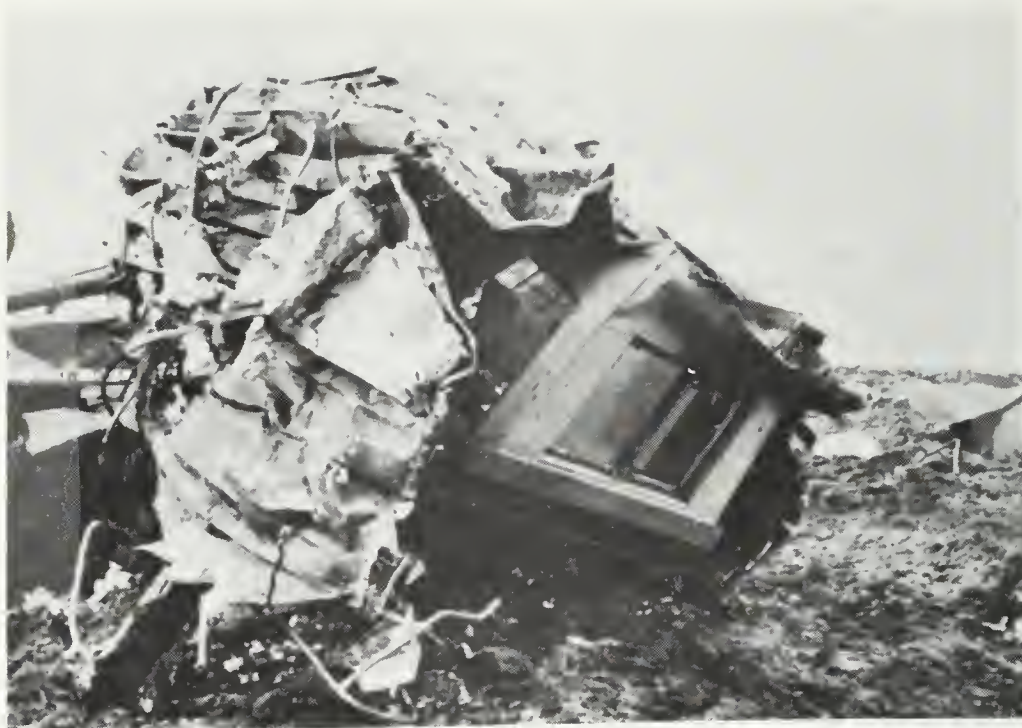
Figure 2.--Caboose of SGTLB-635.

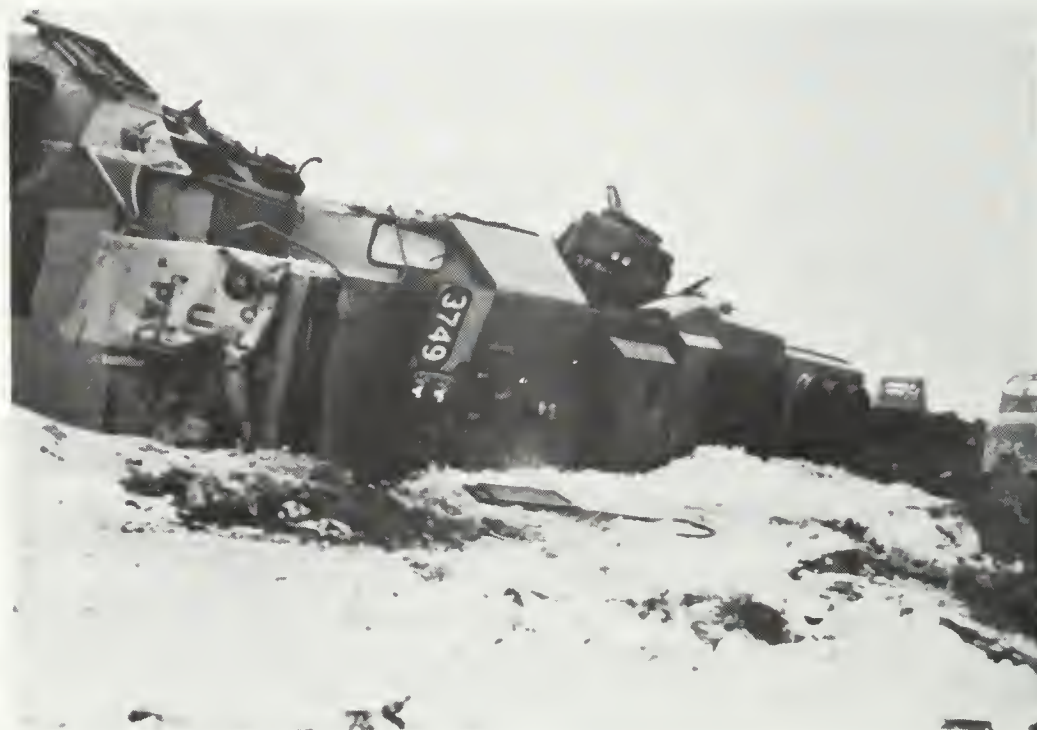
Figure 3.--Locomotive unit No. 3749 of NPH-16.

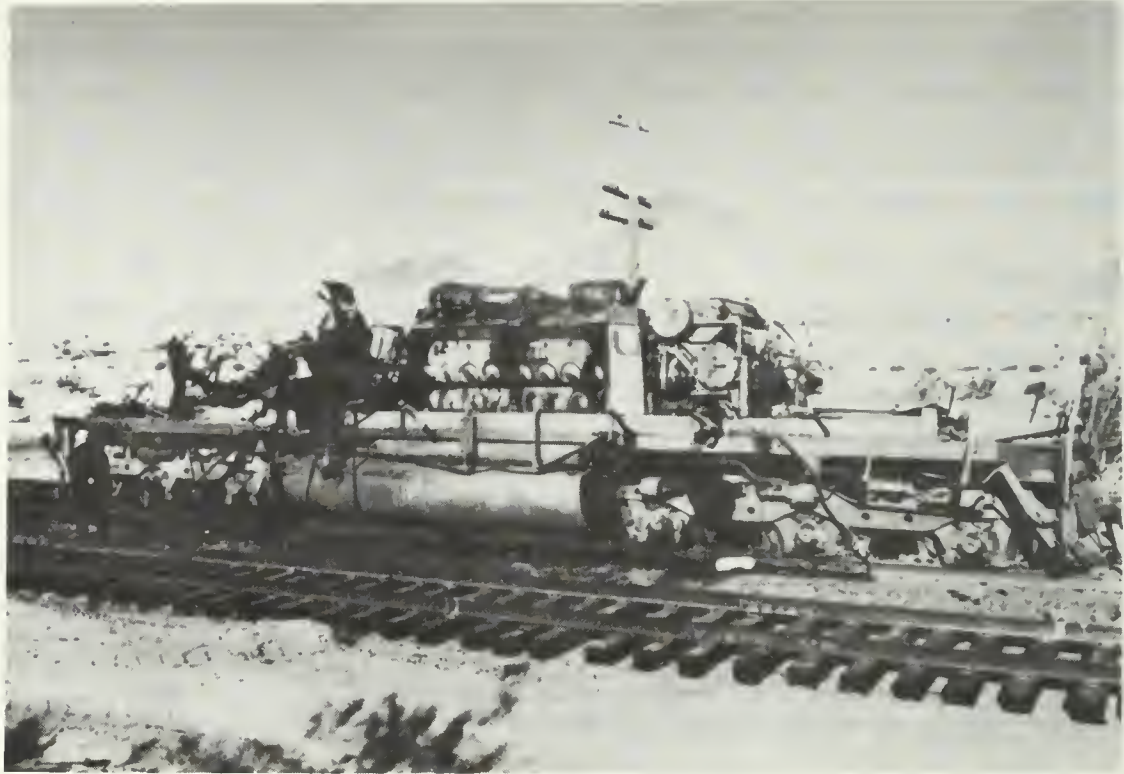
Although the operator compartment of UP 3119 was demolished, it was possible to determine most of the locomotive's control settings after the accident. The throttle was found in "Idle," the reverser was in "Forward," the selector was in "Power," and the brake valve cut-off valve was in "Pass." The independent brake was found fully

Figure 5.--Locomotive unit of Extra 3119 West where it stopped after the accident.

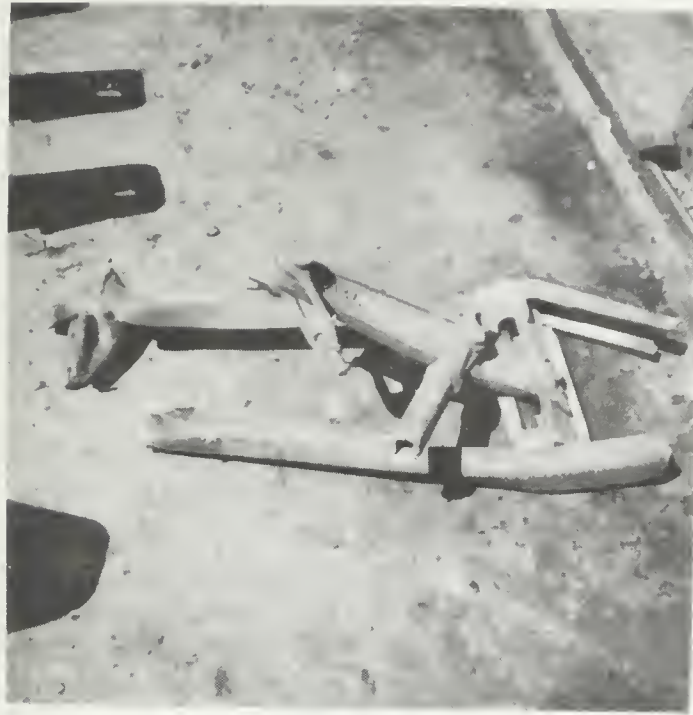
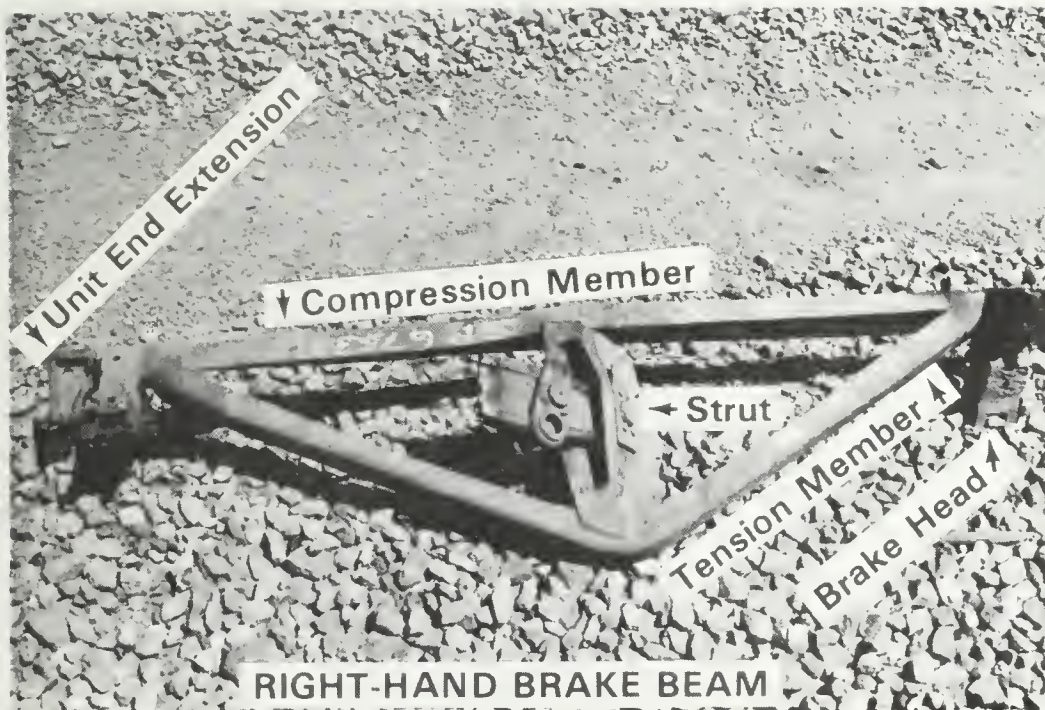
Figure 5.—Damaged brake beam identified as being the No. 4 brake beam from the 53d car (top) and an undamaged brake beam (bottom).

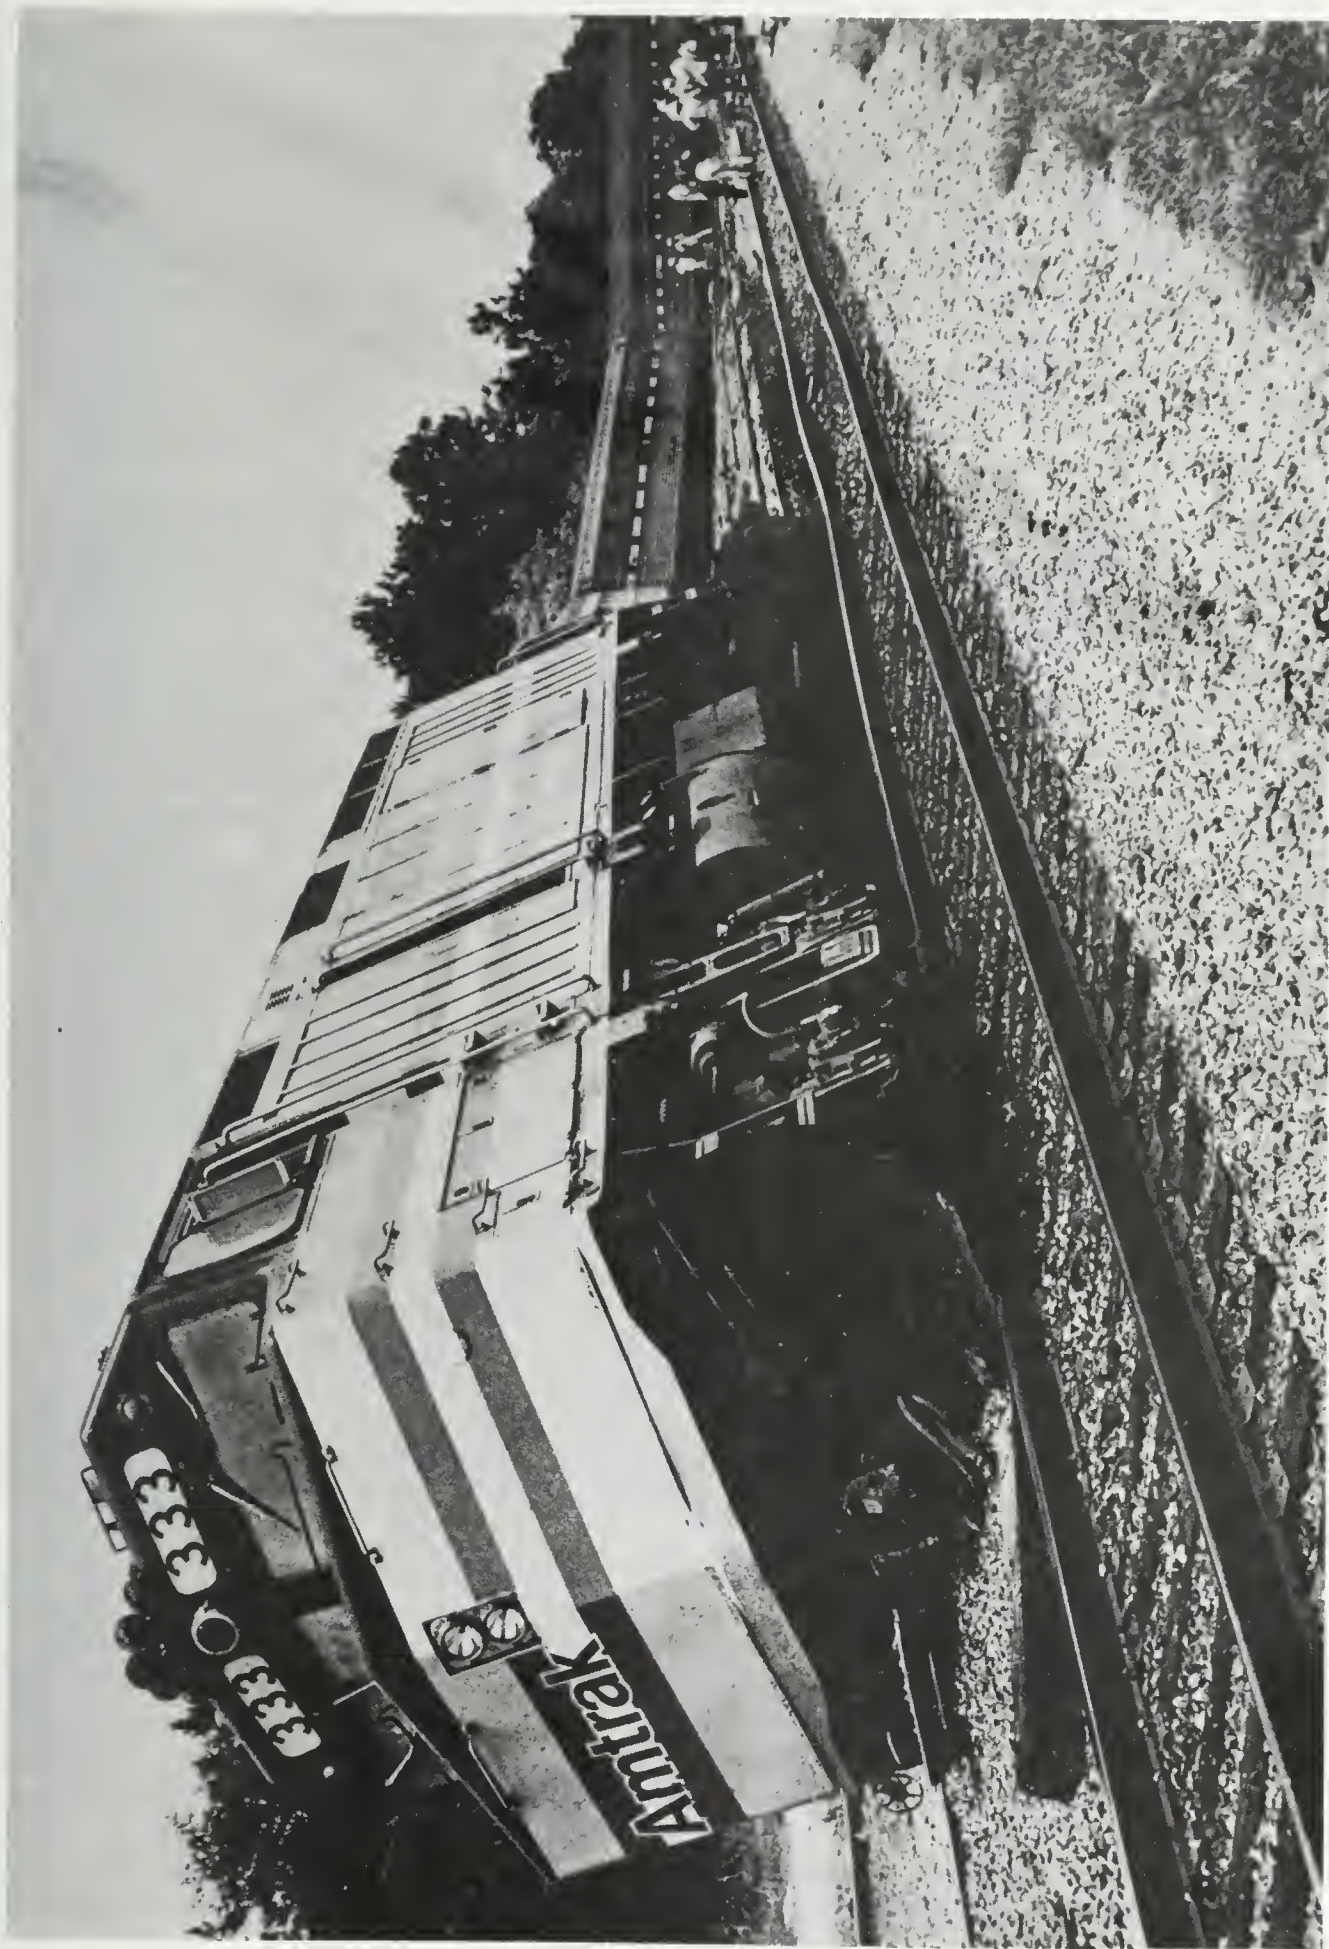
Figure 1.—Derailed locomotive and cars of train No. 97.
